# Manhole Inspection Summary

Manhole # S13GG\_023MH

**Location** Address: **REAR OF 1522 POPLAR GROVE ST** Cross Street: **BRIGHTON ST**

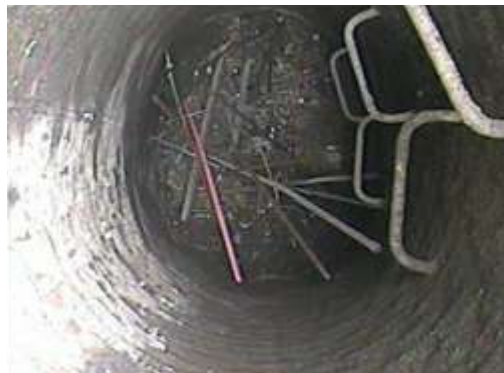
Top View

Comments **HEAVY DEBRIS**

Condition: ☐ Sound ☐ Cracked ☐ Root Intrusion ☐ Deteriorated ☐ Leaks ☒ **Debris**

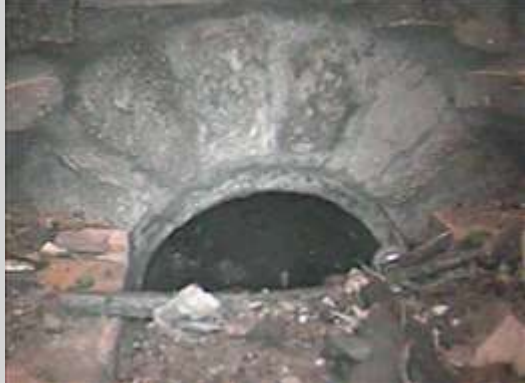
12 O'Clock Outflow

8 in. Circular Gravity Sewer  
Pipe Out @ 12 O'Clock

Deposits: ☐ None ☐ Mud ☐ Sludge ☒ **Debris** ☐ Grease

Silt Depth: **6** (in.) Deposits Extent: **Heavy**
